## Flood Damage Reduction Segment / System Inspection Report

Name of Segment / System: Souris River-Burlington to Minot - Kings Court

Corps of Engineers Inspector: Luke Schmidt and Joe Hemmer

Inspection Start Date: 10/29/2019

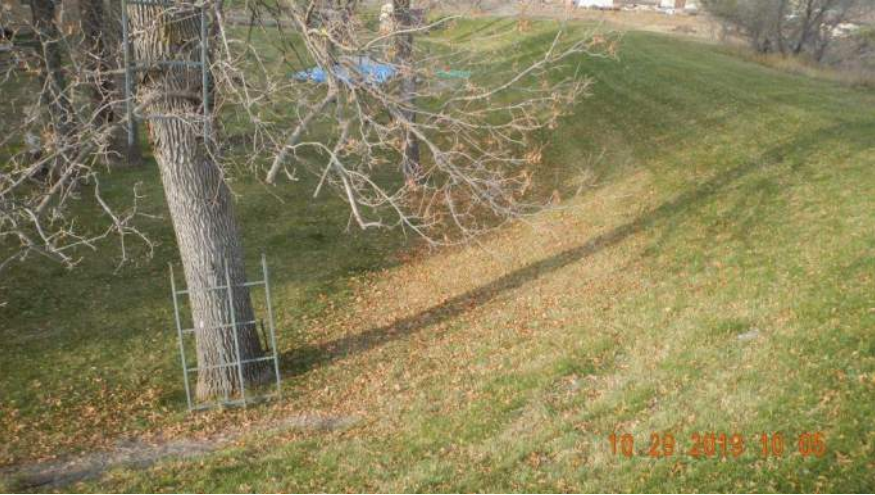
<p><b>Inspect ID:</b> BMKC_2019_a_0013 <b>Title:</b> USACE_CEMVP_BMKC_2019_a_0013_4.jpg <b>Rated Item:</b> 1. Unwanted Vegetation Growth <b>Caption:</b> Rating: Unacceptable; Remarks: Unwanted vegetation located within the levee prism and along the landside toe. Trees greater than 2 inches in diameter and overgrown bushes; Action: Remove unwanted vegetation from vegetation-free zone, up to the levee easement. Remove root ball, backfill, compact in lifts, and reseed with grass. Ensure environmental compliance with all appropriate agencies prior to removal; Station_1: 17+00; Station_2: 40+50</p>

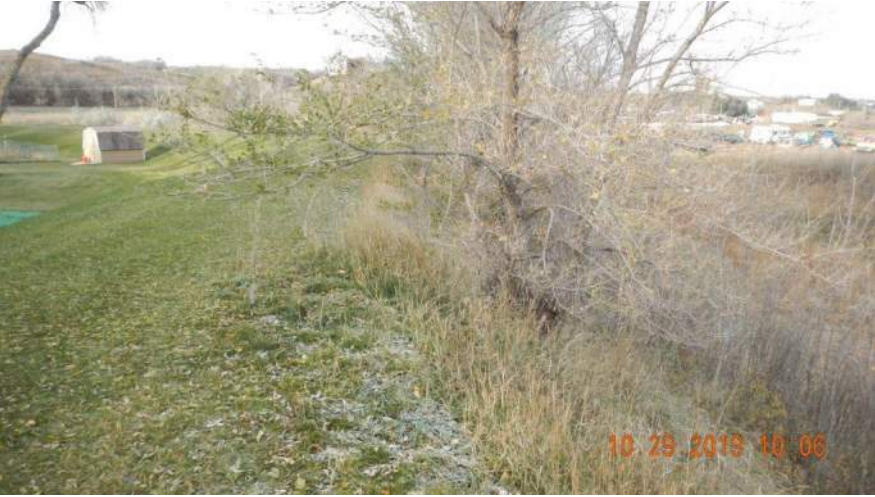
<p><b>Inspect ID:</b> BMKC_2019_a_0051 <b>Title:</b> USACE_CEMVP_BMKC_2019_a_0051_1.jpg <b>Rated Item:</b> 1. Unwanted Vegetation Growth <b>Caption:</b> Rating: Unacceptable; Remarks: Multiple trees with trunks &gt;2 inches in diameter and overgrown vegetation growth on riverside slope of the levee; Action: Remove unwanted vegetation from vegetation-free zone, up to the levee easement. Remove root ball, backfill, compact in lifts, and reseed with grass. Mow overgrown vegetation. Ensure environmental compliance with all appropriate agencies prior to removal; Station_1: 36+50; Station_2: 43+21</p>

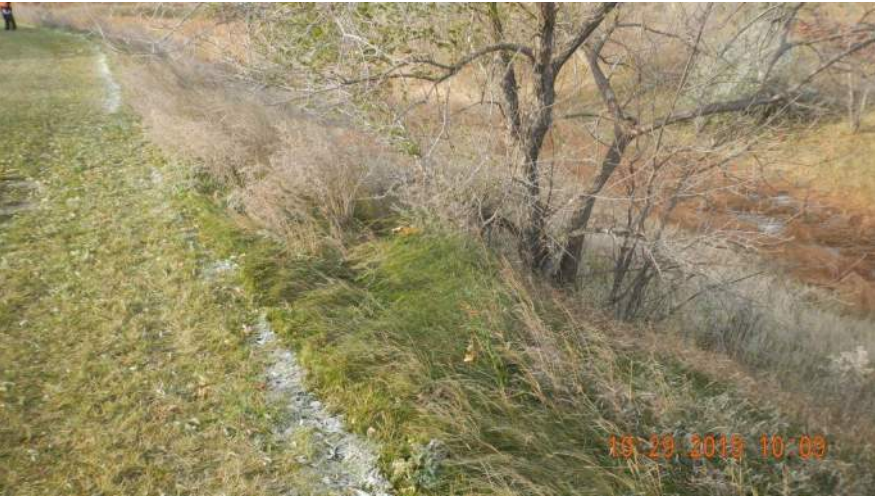
<p><b>Inspect ID:</b> BMKC_2019_a_0051 <b>Title:</b> USACE_CEMVP_BMKC_2019_a_0051_2.jpg <b>Rated Item:</b> 1. Unwanted Vegetation Growth <b>Caption:</b> Rating: Unacceptable; Remarks: Multiple trees with trunks &gt;2 inches in diameter and overgrown vegetation growth on riverside slope of the levee; Action: Remove unwanted vegetation from vegetation-free zone, up to the levee easement. Remove root ball, backfill, compact in lifts, and reseed with grass. Mow overgrown vegetation. Ensure environmental compliance with all appropriate agencies prior to removal; Station_1: 36+50; Station_2: 43+21</p>

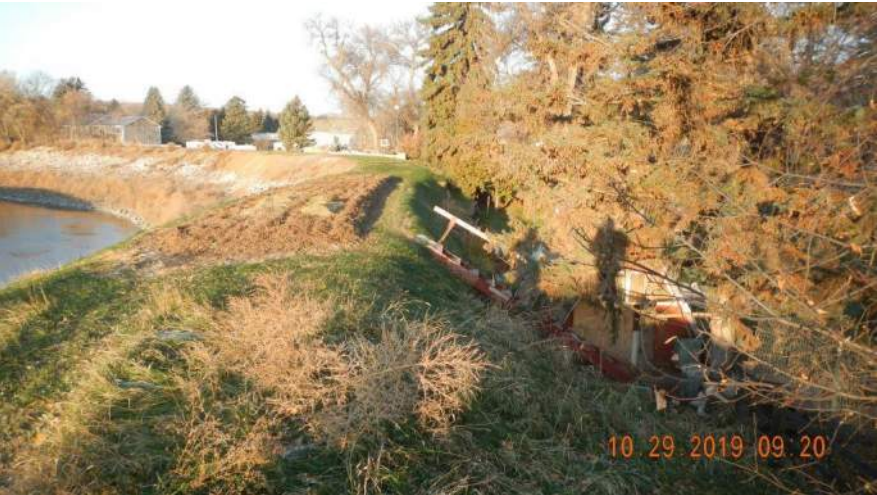
<p><b>Inspect ID:</b> BMKC_2019_a_0062 <b>Title:</b> USACE_CEMVP_BMKC_2019_a_0062_1.jpg <b>Rated Item:</b> 1. Unwanted Vegetation Growth <b>Caption:</b> Rating: Unacceptable; Remarks: Unwanted vegetation located within the levee prism and along the landside toe. Trees greater than 2 inches in diameter and overgrown bushes; Action: Remove unwanted vegetation from vegetation-free zone, up to the levee easement. Remove root ball, backfill, compact in lifts, and reseed with grass. Ensure environmental compliance with all appropriate agencies prior to removal; Station_1: 0+00; Station_2: 14+00</p>

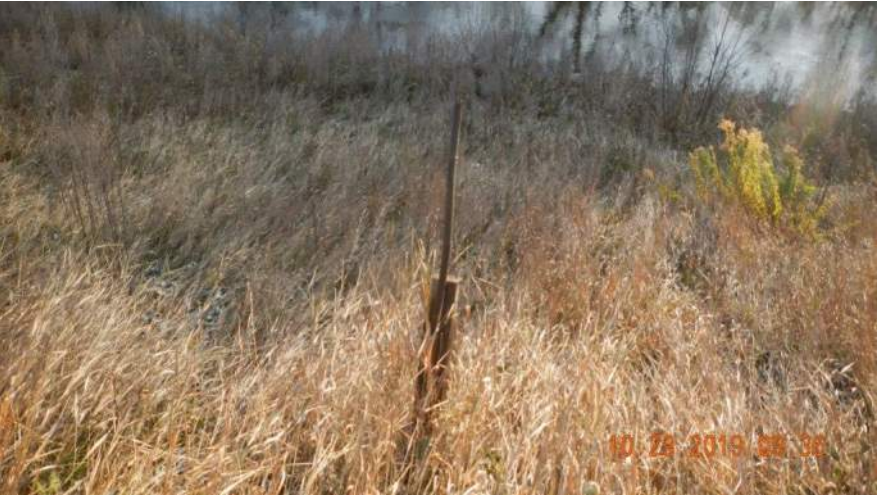
<p><b>Inspect ID:</b> BMKC_2019_a_0063 <b>Title:</b> USACE_CEMVP_BMKC_2019_a_0063_1.jpg <b>Rated Item:</b> 1. Unwanted Vegetation Growth <b>Caption:</b> Rating: Unacceptable; Remarks: Trees greater than 2 inches in diameter and overgrown vegetation along the riverside slope of the levee embankment and appears to be within the vegetation free zone; Action: Remove unwanted vegetation from vegetation-free zone, up to the levee easement. Remove root ball, backfill, compact in lifts, and reseed with grass. Ensure environmental compliance with all appropriate agencies prior to removal; Station_1: 7+00; Station_2: 0+00</p>

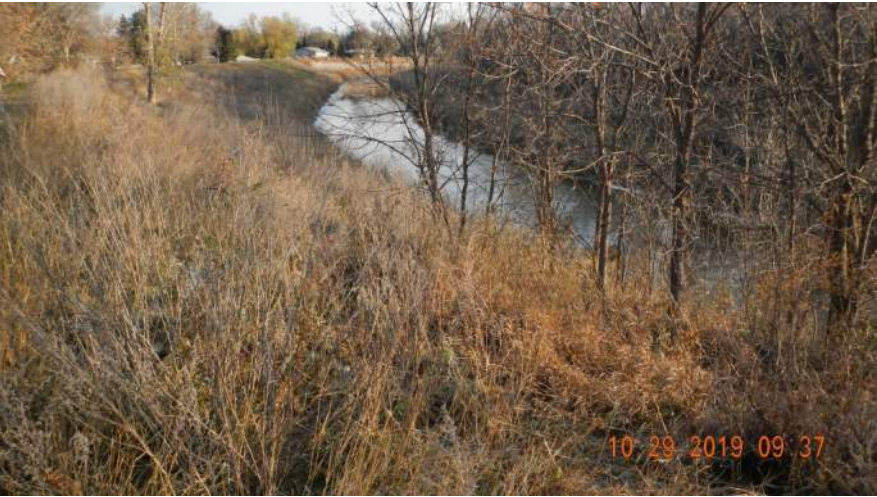
<p><b>Inspect ID:</b> BMKC_2019_a_0063 <b>Title:</b> USACE_CEMVP_BMKC_2019_a_0063_2.jpg <b>Rated Item:</b> 1. Unwanted Vegetation Growth <b>Caption:</b> Rating: Unacceptable; Remarks: Trees greater than 2 inches in diameter and overgrown vegetation along the riverside slope of the levee embankment and appears to be within the vegetation free zone; Action: Remove unwanted vegetation from vegetation-free zone, up to the levee easement. Remove root ball, backfill, compact in lifts, and reseed with grass. Ensure environmental compliance with all appropriate agencies prior to removal; Station_1: 7+00; Station_2: 0+00</p>

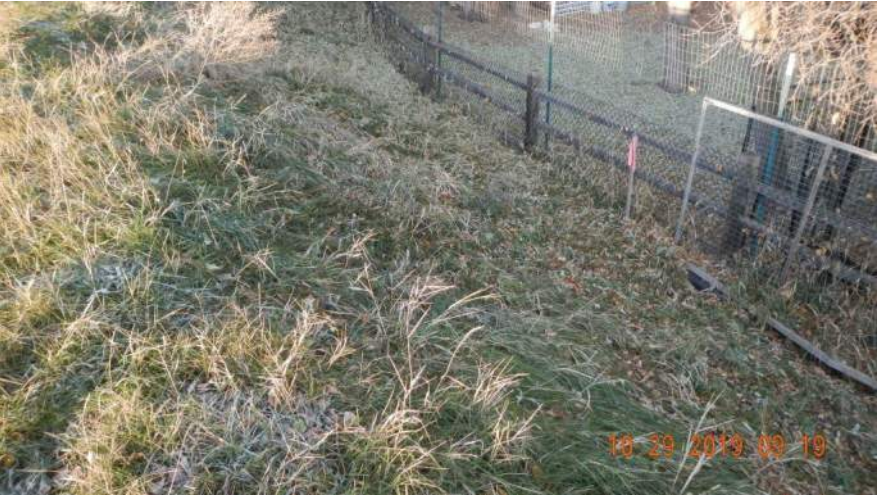
<p><b>Inspect ID:</b> BMKC_2019_a_0014 <b>Title:</b> USACE_CEMVP_BMKC_2019_a_0014_11.jpg <b>Rated Item:</b> 3. Encroachments <b>Caption:</b> Rating: Unacceptable; Remarks: Multiple homeowner encroachment located on the levee and at the landside toe. These include multiple irrigation lines passing through levee crown, pumps, fences, retaining wall, decks, and misc items; Action: Verify levee easement and relocate encroachments/debris outside of levee easement, unless approved by Corps; Station_1: 0+00; Station_2: 32+06</p>
 	<p><b>Inspect ID:</b> BMKC_2019_a_0014 <b>Title:</b> USACE_CEMVP_BMKC_2019_a_0014_12.jpg <b>Rated Item:</b> 3. Encroachments <b>Caption:</b> Rating: Unacceptable; Remarks: Multiple homeowner encroachment located on the levee and at the landside toe. These include multiple irrigation lines passing through levee crown, pumps, fences, retaining wall, decks, and misc items; Action: Verify levee easement and relocate encroachments/debris outside of levee easement, unless approved by Corps; Station_1: 0+00; Station_2: 32+06</p>

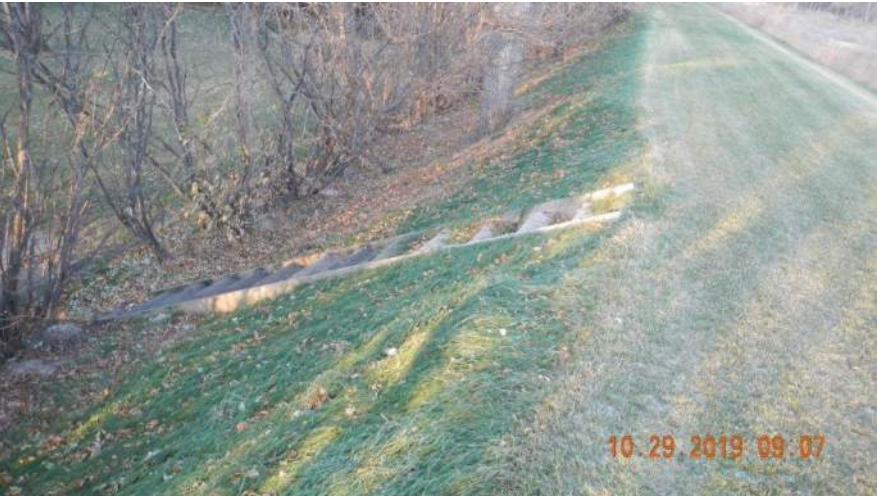
Rated Item	Rating	Rating Guidelines		Location/Remarks/Recommendations
5. Slope Stability	<b>M</b>	<b>A</b>	No slides, sloughs, tension cracking, slope depressions, or bulges are present.	BMKC_2019_a_0020: Station_1 21+91: Steep land side levee slope: Remedial actions required to restore levee slope per plan. Further evaluation is required. Solutions must be approved by Corps. Verify fill placement approved by the Corps. (M) BMKC_2019_a_0052: Station_1 38+86: Unauthorized raise of an unknown amount: Survey levee crest and submit information to Corps. If already surveyed, please submit data (M)
		<b>M</b>	Minor slope stability problems that do not pose an immediate threat to the levee embankment.	
		<b>U</b>	Major slope stability problems (ex. deep seated sliding) identified that must be repaired to reestablish the integrity of the levee embankment.

<p><b>Inspect ID:</b> BMKC_2019_a_0020 <b>Title:</b> USACE_CEMVP_BMKC_2019_a_0020_1.jpg <b>Rated Item:</b> 5. Slope Stability <b>Caption:</b> Rating: Minimally Acceptable; Remarks: Steep land side levee slope; Action: Remedial actions required to restore levee slope per plan. Further evaluation is required. Solutions must be approved by Corps. Verify fill placement approved by the Corps.; Station_1: 21+91</p>

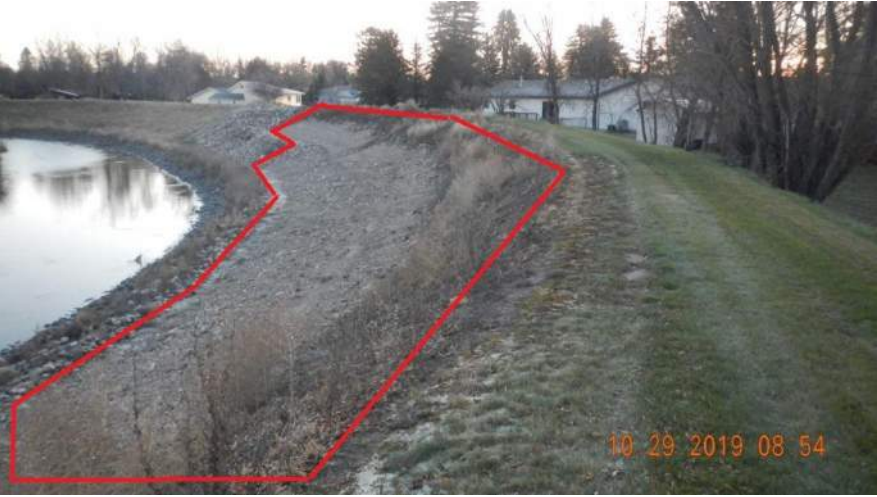
<p><b>Inspect ID:</b> BMKC_2019_a_0061 <b>Title:</b> USACE_CEMVP_BMKC_2019_a_0061_1.jpg <b>Rated Item:</b> 12. Riprap Revetments &amp; Bank Protection <b>Caption:</b> Rating: Unacceptable; Remarks: The upper portion of the riprap has been removed exposing the underneath bedding layer; Action: Replace riprap back to original thickness; Station_1: 36+50; Station_2: 32+50</p>

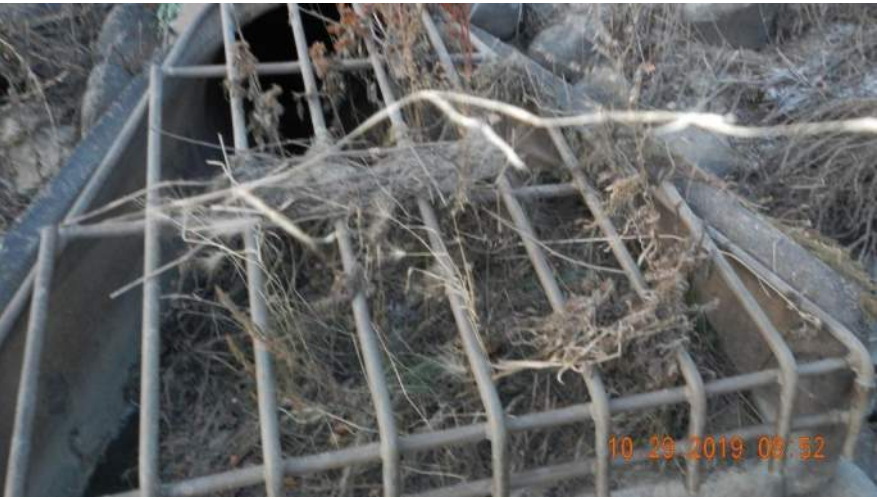
<p><b>Inspect ID:</b> BMKC_2019_a_0010 <b>Title:</b> USACE_CEMVP_BMKC_2019_a_0010_1.jpg <b>Rated Item:</b> 1. Vegetation and Obstructions <b>Caption:</b> Rating: Unacceptable; Remarks: Sediment is obstructing approximately 20% of concrete pipe culvert outlet that discharges from Kings Court Pump Station; Action: Remove sediment and vegetation from drainage feature to reestablish flow in the culvert; Station_1: 35+00</p>

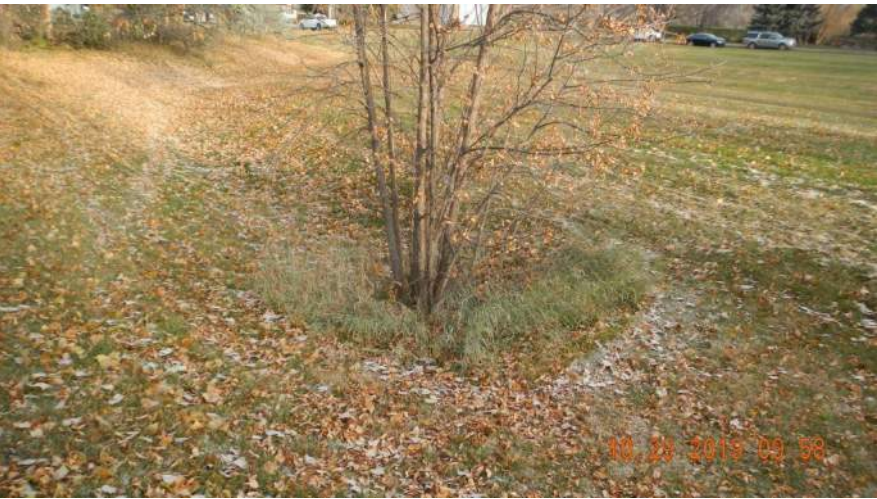
<p><b>Inspect ID:</b> BMKC_2019_a_0045 <b>Title:</b> USACE_CEMVP_BMKC_2019_a_0045_1.jpg <b>Rated Item:</b> 1. Vegetation and Obstructions <b>Caption:</b> Rating: Unacceptable; Remarks: Trees &gt; 2 inch diameter are growing out of 18 inch CMP entering drainage area; Action: Remove all unwanted vegetation; verify trash rack is not damaged. If damaged, repair trash rack; Station_1: 0+00</p>

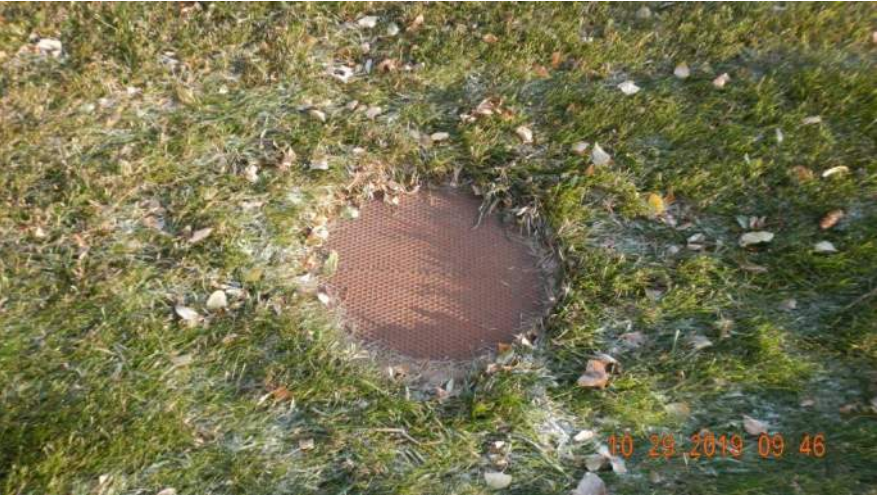
<p><b>Inspect ID:</b> BMKC_2019_a_0040 <b>Title:</b> USACE_CEMVP_BMKC_2019_a_0040_1.jpg <b>Rated Item:</b> 2. Encroachments <b>Caption:</b> Rating: Unacceptable; Remarks: The beehive inlet cover near Manhole No. 6 has been replaced with a solid manhole cover and is likely blocking drainage; Action: Complete an engineering evaluation of drainage conditions and complete remedial action as necessary to facilitate positive drainage; Station_1: 5+00</p>

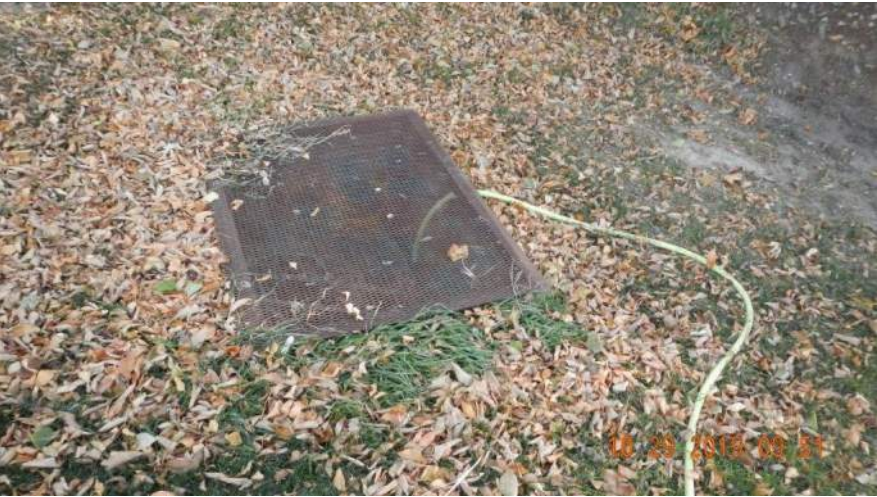
<p><b>Inspect ID:</b> BMKC_2019_a_0043 <b>Title:</b> USACE_CEMVP_BMKC_2019_a_0043_1.jpg <b>Rated Item:</b> 2. Encroachments <b>Caption:</b> Rating: Unacceptable; Remarks: A wooden box has been built around inlet to Manhole No. 4 with a plant placed on top of it. Ditch No. 3 has been filled; Action: Verify drainage easement. Complete an engineering evaluation of drainage conditions and complete remedial action as necessary to facilitate positive drainage; Station_1: 9+50</p>
