Flood Damage Reduction Segment / System Inspection Report

Name of Segment / System: Souris River-Burlington to Minot - Johnson

Public Sponsor(s): Souris River Joint Water Resources Board

Corps of Engineers Inspector: Luke Schmidt and Joe Hemmer Inspection Start Date: 10/29/2019

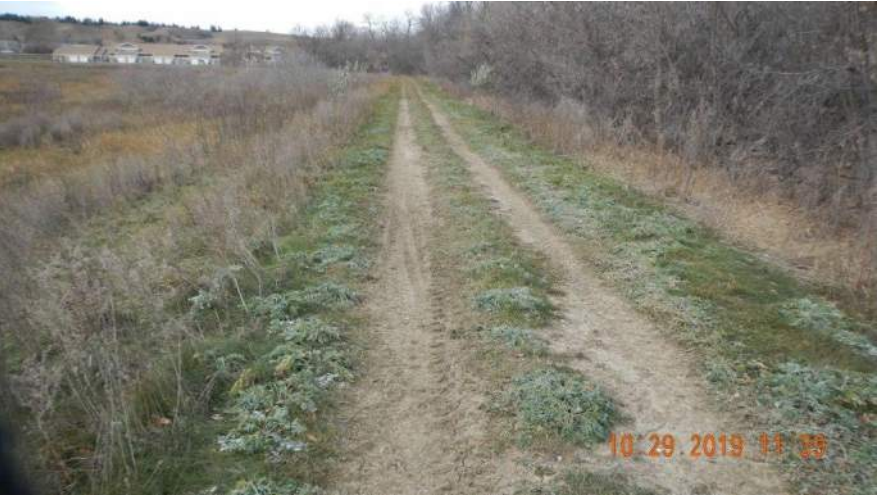
<p>Inspect ID: BMBN_2019_a_0044 Title: USACE_CEMVP_BMBN_2019_a_0044_1.jpg Rated Item: 8. Depressions/ Rutting Caption: Rating: Minimally Acceptable; Remarks: A vehicle trail is located along the top of the levee embankment causing rutting and preventing grass to grow; Action: Post signs prohibiting vehicle use along the top of the embankment. Fill in ruts; Station_1: 0+00; Station_2: 11+50</p>

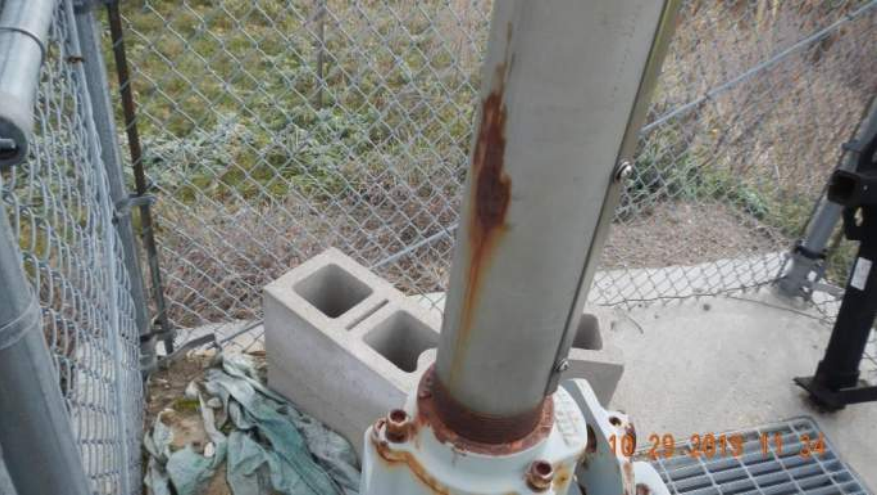
<p>Inspect ID: BMBN_2019_a_0002 Title: USACE_CEMVP_BMBN_2019_a_0002_1.jpg Rated Item: 18. Sluice/ Slide Gates Caption: Rating: Minimally Acceptable; Remarks: Gate lifter has light levels of corrosion which does not pose an immediate risk to the lifter but corrective actions are necessary to prevent additional corrosion; Action: Sand and repaint; Station_1: 7+00</p>
